# Manhole Inspection Summary

Manhole # S15A\_\_017MH

Insp Date: **5/6/09 10:59 AM**

**Location** Address: **617 CLAYMONT AVE**

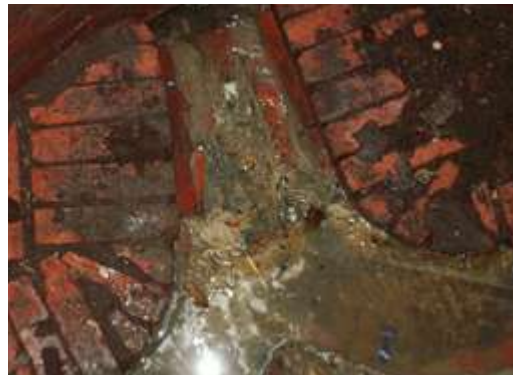
Defect 2

Condition: ☐ Sound ☐ Cracked ☐ Root Intrusion ☐ Deteriorated ☐ Leaks ☒ **Debris**

DEBRIS IN CHANNEL

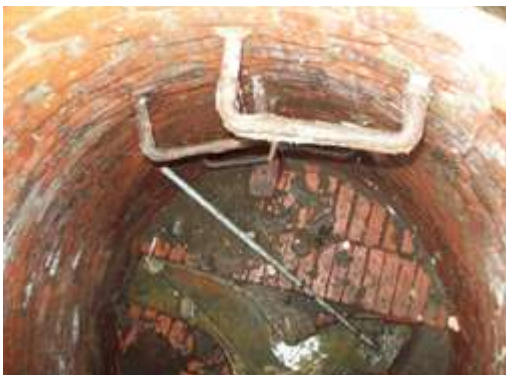
Defect 1

**Steps** Count: **4** Missing: **0** ☒ **Corroded**

CORRODED STEPS

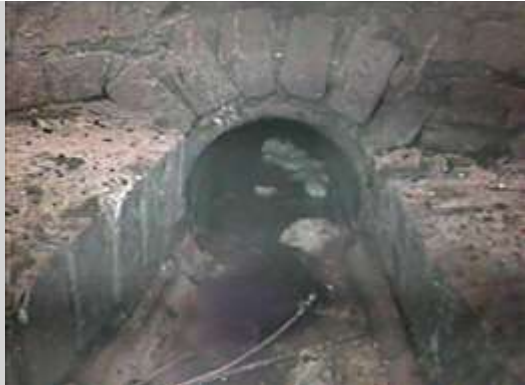
12 O'Clock Outflow

8 in. Circular Gravity Sewer  
Pipe Out @ 12 O'Clock

Deposits: ☐ None ☐ Mud ☒ **Sludge** ☐ Debris ☐ Grease

Silt Depth: **1** (in.) Deposits Extent: **Light**

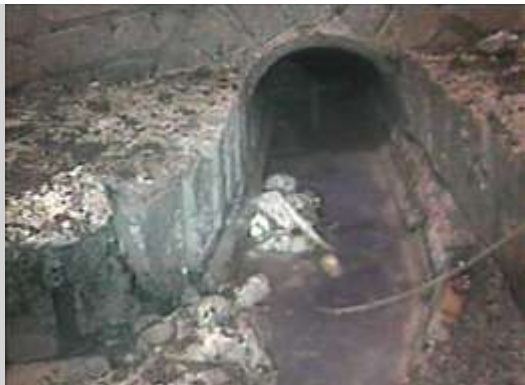
3 O'Clock Inflow

8 in. Circular Gravity Sewer  
Pipe In @ 3 O'Clock

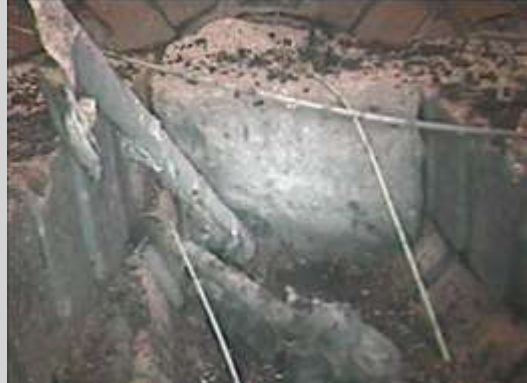
9 O'Clock Inflow

8 in. Circular Gravity Sewer

Pipe In @ 9 O'Clock

Connects To: **Stub connection / abandoned**
